Analysis & Comparison of Old and New Lead Came

by Veda-Anne Ulcickas, Materials Engineer

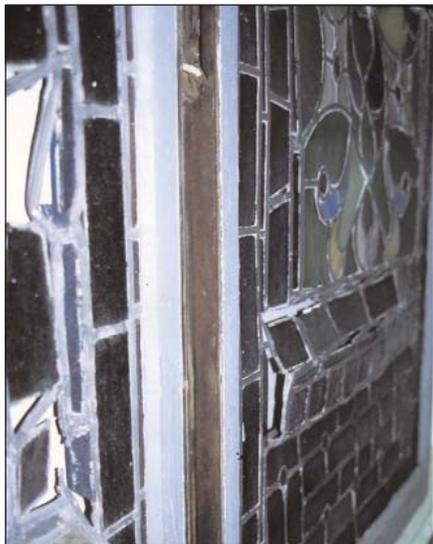
An aging window with lead that is cracked, deformed and nearing structural failure.

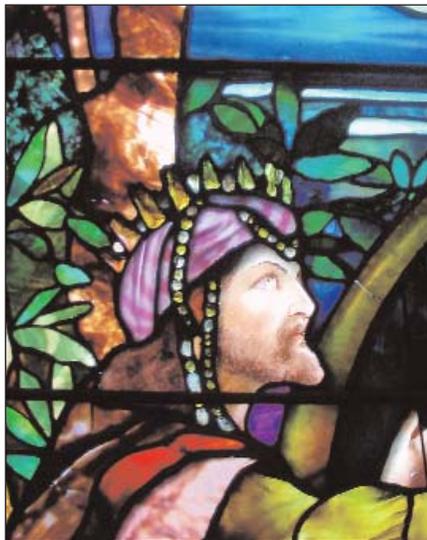
An intricately leaded, complex figure from a Tiffany window, before restoration.

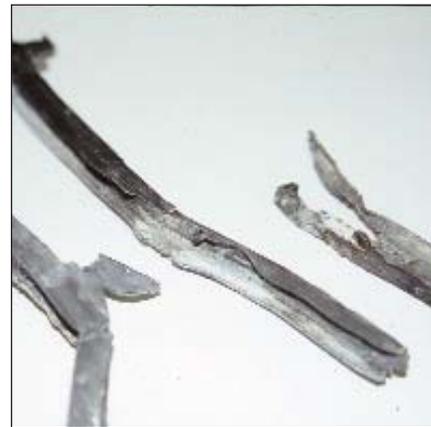
Samples of deteriorated lead came from the Tiffany window at left.

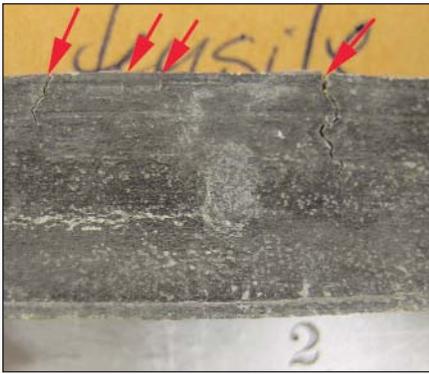
Fig. 1: Cracks (arrows) in 1913 lead (sample A), as received.

Visual examination of the older comes revealed a multitude of fine cracks extending into the came from its outer edges. Figure 1 (page 53) shows several of these cracks along a one-inch length of Sample A. The older joints revealed widespread cracking as well.

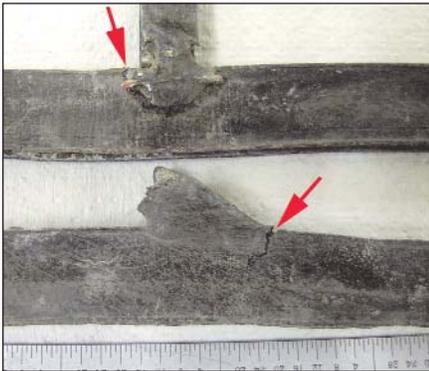
Fig. 2: Cracks (arrows) in 1913 joint (sample A), as received.

Figures 2 and 3 (page 53) show joint cracks in Sample A. The crack in the lower joint shown in Figure 2 was later examined with EDS analysis. For comparison, Sample E, a new joint on new lead is shown in Figure 4 (page 53). Visible cracks were common to all older samples and not present on new samples. Since the cracking visible with the naked eye is not necessarily the only cracking present, further microscopic examination was performed.

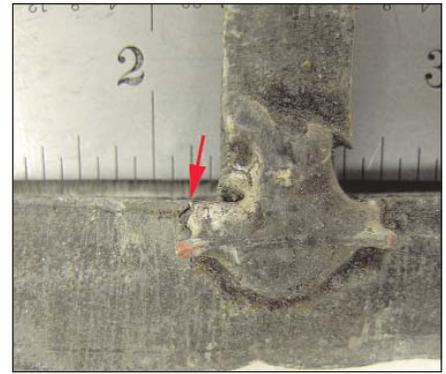
Fig. 3: Close up of Fig. 2 solder joint crack (arrow).

As Figure 3 shows, cracking at resoldered joints is a concern. In addition to the crack, note the jagged came form and melt-through regions at this T-joint. These are all hallmarks of a poor bond. The melt-through and jagged eaten-away appearance of the came results from too high heat and/or too long a contact between the soldering tool and the came in these regions. All the stress-raiser issues previously discussed regarding uneven geometry are illustrated here. Cracks in the weld toe region, common in the samples examined from different windows, are the result of the metal attempting to accommodate strains induced by the soldering. This can be

due to excessive heat application, entrapped flux, creation of brittle intermetallic compounds, or poor stress distribution elsewhere along the came due to other repair work.

The prominence of such cracks in the samples examined from different sources suggests that they are less the result of the skill level of the person resoldering the joint (although the overall quality of the Figure 3 joint is very low) than of the difficulty in properly cleaning and designing a repair joint involving old, oxidized lead.

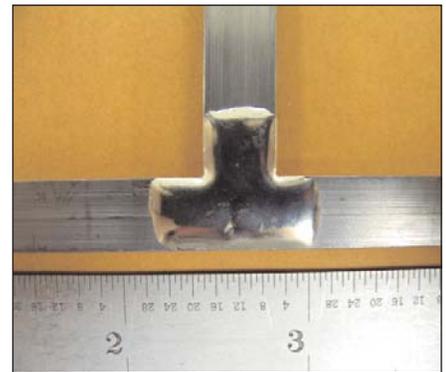
Fig. 4: New solder joint on new lead (sample E).

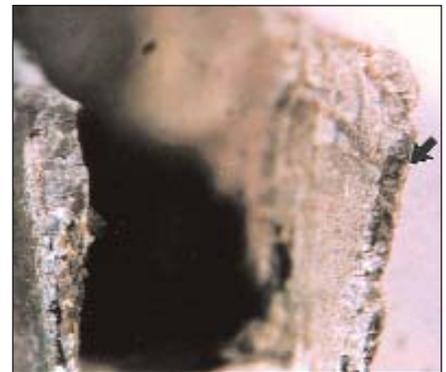
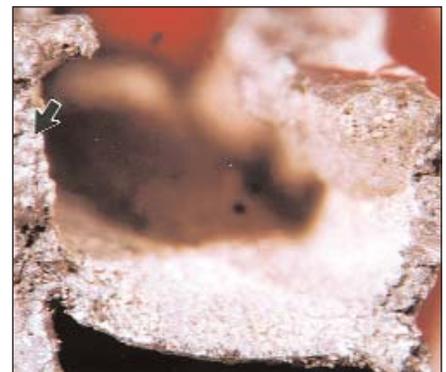
Fig. 5: Fracture surface of 1913 lead (sample A). Mag. 12X

Fig. 6: Fracture surface of 1930 lead (sample B). Mag. 12X

Figures 5 and 6 (page 53) show the fracture surfaces of cracks in the came Samples A and B, respectively. Both photographs were taken with the same settings under the same lighting conditions within minutes of each other. Note that the fracture surface of the Sample A crack is noticeably darker than that of the Sample B crack. A portion of the laboratory-created fracture is visible in Figure 6. This laboratory-created crack is knife-edged and shiny. Contrast this bright, shiny appearance with the older fracture surfaces. The darker fracture surfaces are likely the result of greater oxidation. To verify that greater oxidation is the cause of the difference in appearance, these fracture surfaces were examined in a scanning electron microscope.

The surfaces of the cracks shown in Figures 5 and 6 were examined in both the as-received and cleaned conditions. The oxide layer present on both surfaces obscured the fracture features in the as-received condition, so a light cleaning solution of a substance known as Alconox was used to remove it. After cleaning, both fracture surfaces exhibited ductile dimple rupture fracture mode with extensive stretching and tearing, Figure 7 (page 55). This indicates a very ductile, or deformable, metal. This is the same fracture mode that most ductile met-

als exhibit under tensile testing, except that the test specimens typically lack the tearing features. It represents exposure of the metal to a force beyond its physical capabilities to withstand. Such tearing could occur from unusually high wind gusts, undersized comes, lead creep, out-of-alignment panes, or the weight of the glass over time.

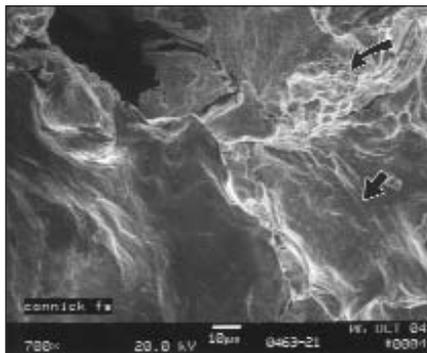
Fig. 7: Sample A fracture. SEM shows ductile dimple rupture and wide patches of ductile tearing (straight arrow). Mag. 700X

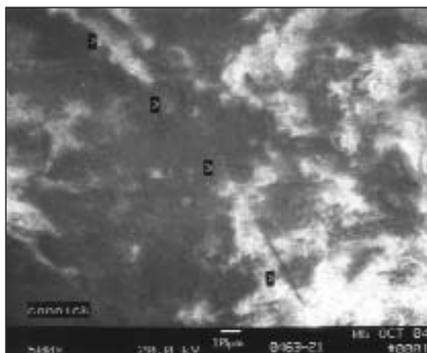
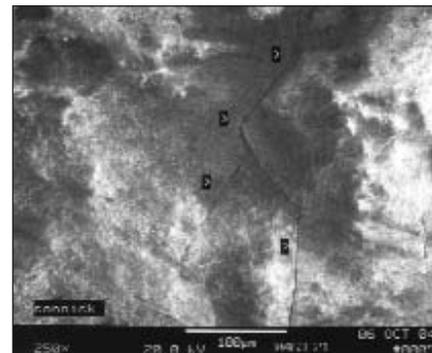
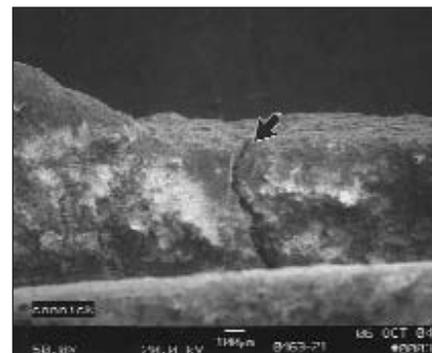
Fig. 8: Sample A cracking (arrows) on flat surface proceeds into lead beyond oxide. Mag. 500X

Fig. 9: Sample A cracking (arrows) on flat surface proceeds into lead beyond oxide. Mag. 250X

Fig. 10: Sample A large crack (arrow) in came near solder. Mag. 50X

third of them possessed a crack. Several of these cracks are shown in Figures 8 through 10 (page 55). Note that the magnifications in these figures range from 50X to 500X. None of these cracks was visible to the naked eye, and only one was visible at 15X (shown in Figure 10 at 50X for greater clarity). Figure 11 (page 55) shows the region where the crack pictured in Figure 8 was located. Note that it is not visible at 15X. This means that any repairs carried out on visible cracks leave a multitude of cracks untouched and unremedied.

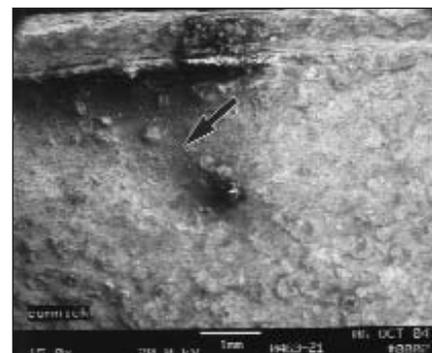
Fig. 11: Location of cracks (arrow) on Sample A lead came. Mag. 15X

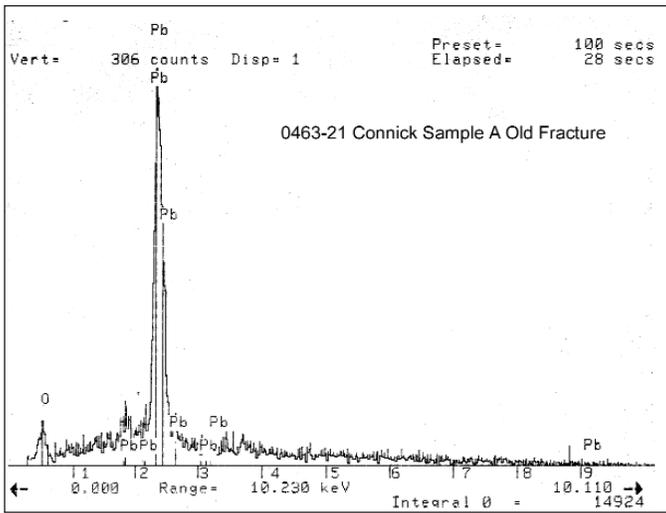
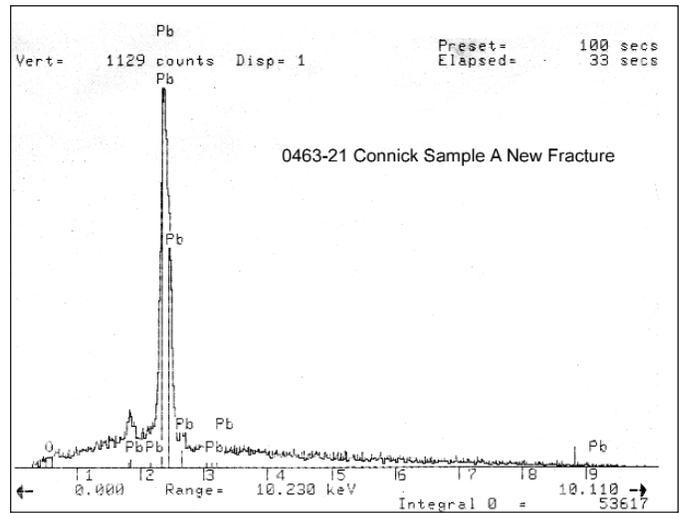
Fig. 12: Sample A old fracture EDS spectrogram.

Fig. 13: Sample A new (laboratory-created) fracture EDS spectrogram.

Figures 12 and 13 (page 56) are the spectrograms for Sample A old fracture (present when sample was received) and new fracture (laboratory-created). The difference in oxygen levels is readily apparent with the old fracture possessing an oxygen peak approximately three times as high as the laboratory-created fracture.

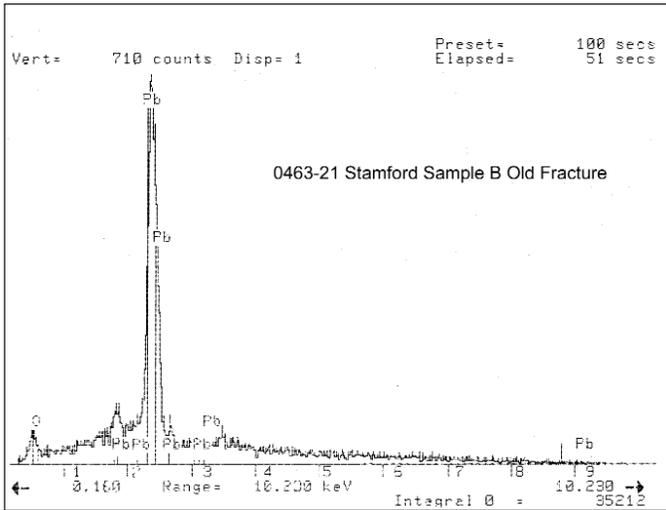
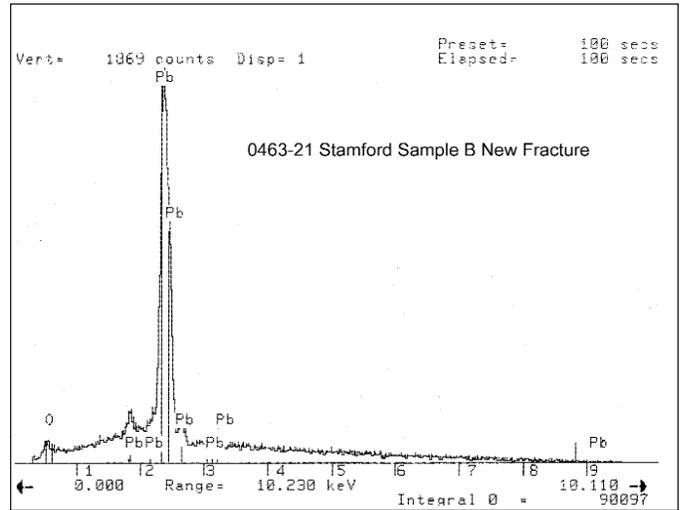
Fig. 14: Sample B old fracture EDS spectrogram.

Fig. 15: Sample B new (laboratory-created) fracture EDS spectrogram.

The difference is a little less striking in Figures 14 and 15 (page 56), which show the old and laboratory-created fracture oxygen levels of Sample B. The old fracture oxygen peak is approximately half again as high as the new fracture peak. Recall that Sample B is younger than Sample A, so age-related cracking would likely occur later in Sample B, assuming similarity of stresses and environment. This translates into less oxidation time for the Sample B crack than for the Sample A crack.

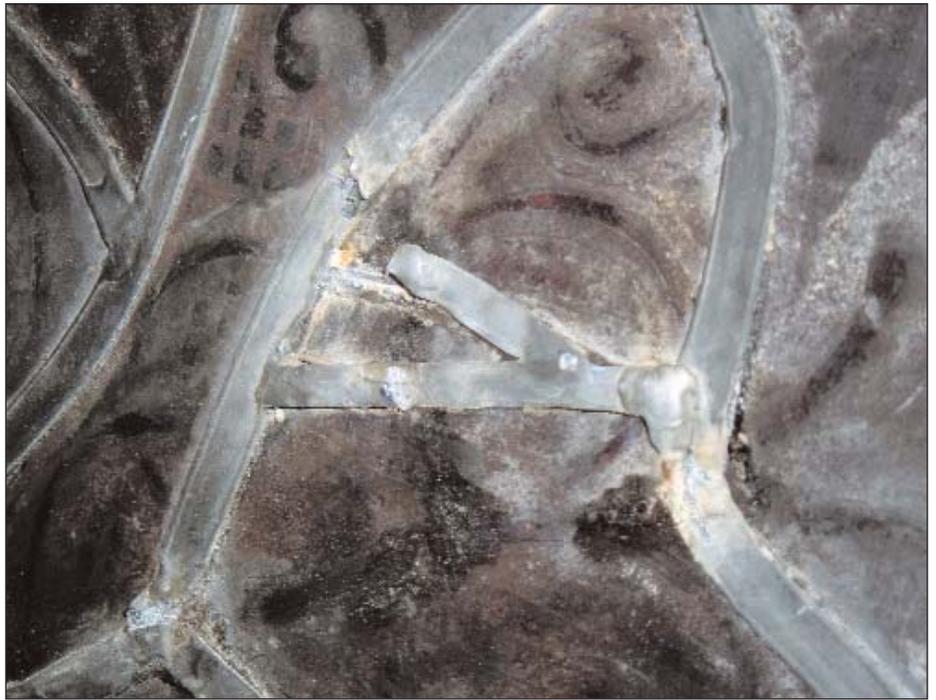
An unsuccessful attempt to resolder old oxidized lead came.

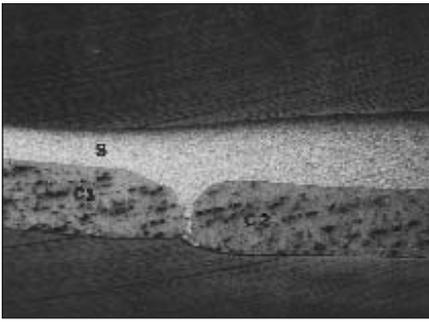
Fig. 16: Sample E, new solder (S) joint on two new cames (C1 and C2). As-polished. Mag. 25X

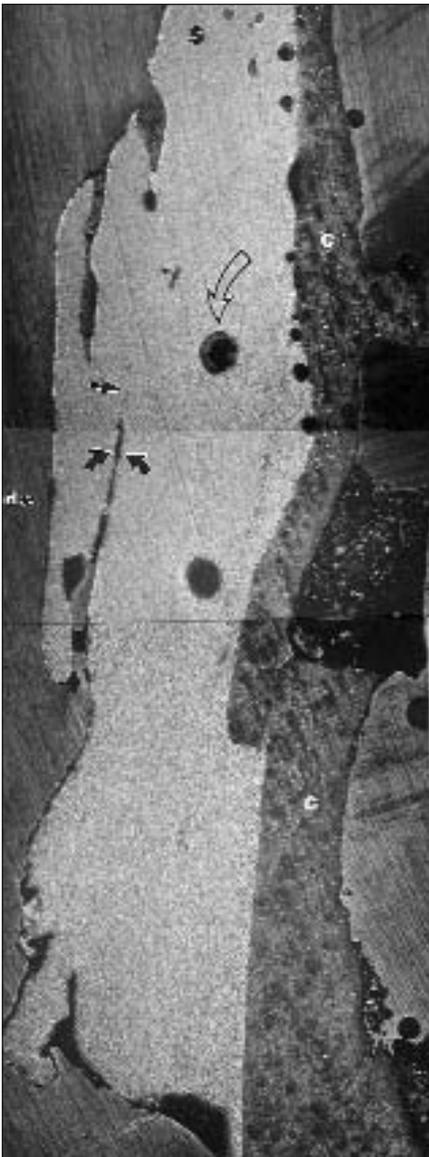
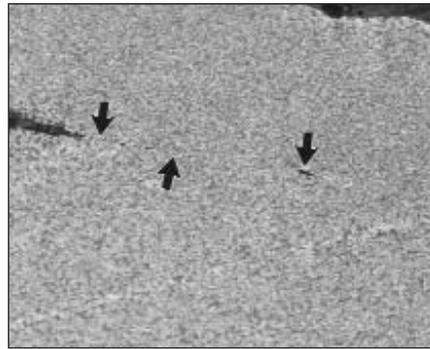
Figure 17 shows a joint, Sample F, that was resoldered in the mid-1970s. Note the dark, round shapes indicative of porosity and how the new solder appears from the OD to join a much larger amount of metal than it actually does. At higher magnification, the extent of the lack of fusion is revealed to be even greater than it originally appeared in the lower magnification view, Figure 18. Large regions of porosity and lack of fusion such as this should not be present in a structural joint. The smooth profile of the new joint and solid fill of its solder provide a joint of greater soundness than the material of the resoldered joint. Porosity and lack of fusion represent discrete regions where gaps in the joint exist. The jagged profile of the joint creates sites known as "stress raisers," or places where the stresses the joint experiences are magnified due to geometry. Stress raisers can accelerate joint failure.

Fig. 17: Sample E, old resoldered (1970s) joint showing solder (s) with porosity (curved clear arrow) and lack of fusion (curved solid arrows). Note that the lack of fusion extends to the small straight arrow above the two curved solid arrows. Mag. 18.75X

Fig. 18: Higher magnification view of Fig. 17 lack of fusion (arrows). As-polished. Mag. 100X

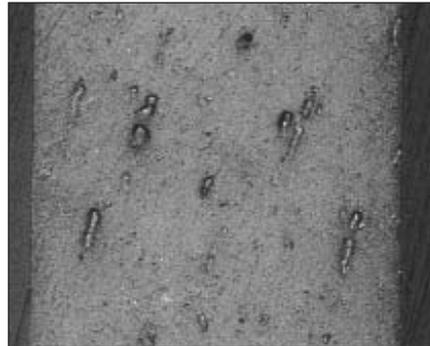
Fig. 19: New came (Sample C) in cross section showing no visible oxide layer. As-polished. Mag. 120X

files of the came walls of the new sample, Sample C, and of older cames, Samples A and B, respectively. As expected, the new came, shown in Figure 19, possesses no visible oxide layer. Sample A, Figure 20, possesses a well-developed, tightly adhered oxide layer on the came OD. Debris visible on the came ID is caulking remnant. The oxide layer is approximately 0.008 inch thick. Lead is known to produce a protective oxide layer, so this very thin layer is expected and normal, even after approximately 91 years.

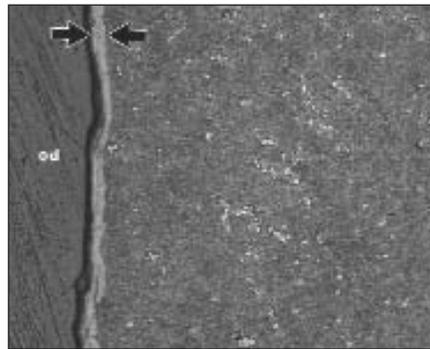
Fig. 20: Oxide layer (arrows) on 1913 came (Sample A). As-polished. Mag. 150X

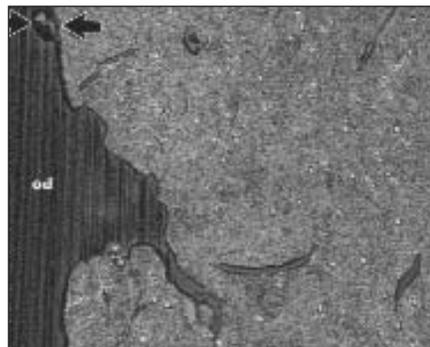
Fig. 21: Oxide layer remnant (arrows) on 1930 came (Sample B). As-polished. Mag. 150X

Sample B, dating from the 1930s, is shown in Figure 21. The oxide layer present on this sample is approximately 0.0005 inch thick. The thickness difference is negligible and the non-continuous layer of Sample B was very likely caused by oxide spalling, or falling off, during removal from its window.

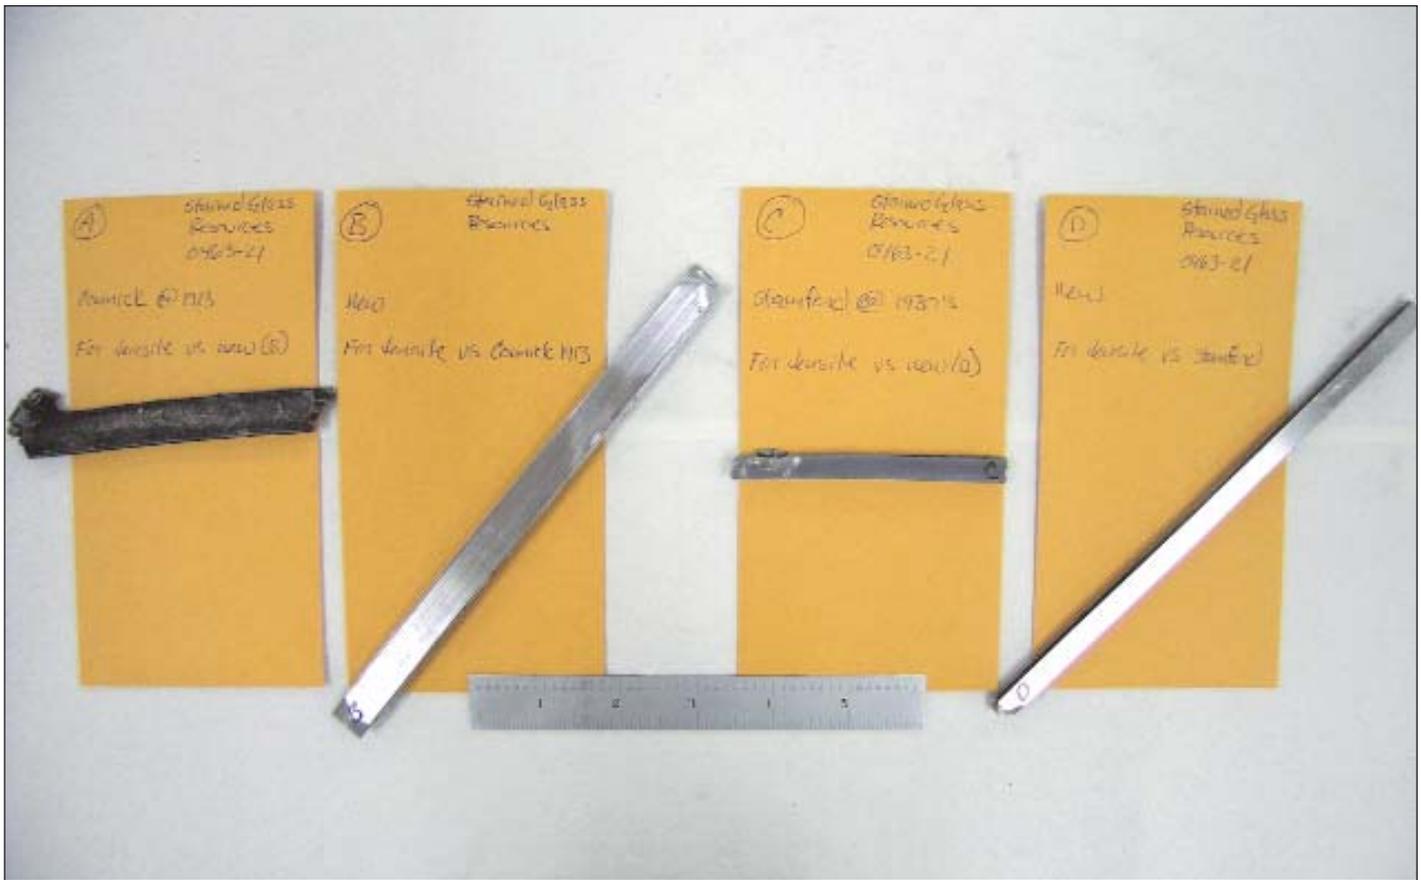
This provided a real-world comparison between samples, as cracks present in the old comes were not eliminated by machining. The results of this testing are summarized in Table II. Note that the sample designations here are specific to this testing and do not refer to Table I sample designations. The new comes tested were chosen based upon size to compare with older comes. This means that one new Sample B was the same size and configuration as Sample A; and Sample D was the same size and configuration as Sample C. This is shown in Figure 22. These results indicate that the strength of a new came is a minimum of two and a half times that of an old came. In other words, using a new came provides 250% more tensile strength than the old comes. Since the lead comes are the structural framework for the glass, this translates into a much greater ability to withstand the weight of the glass and the wind loads to which windows are subjected. This is significant because SEM examination of an older crack fracture surface showed a fracture mode consistent with an overload failure, the same type of failure a tensile test produces.

Figure 22: Old and new came samples for tensile testing.
